# 9944 Improved Criteria for Acceptable Yield Point Elongation of Surface Critical Steels

## Stretcher Strains in Low Carbon Steel

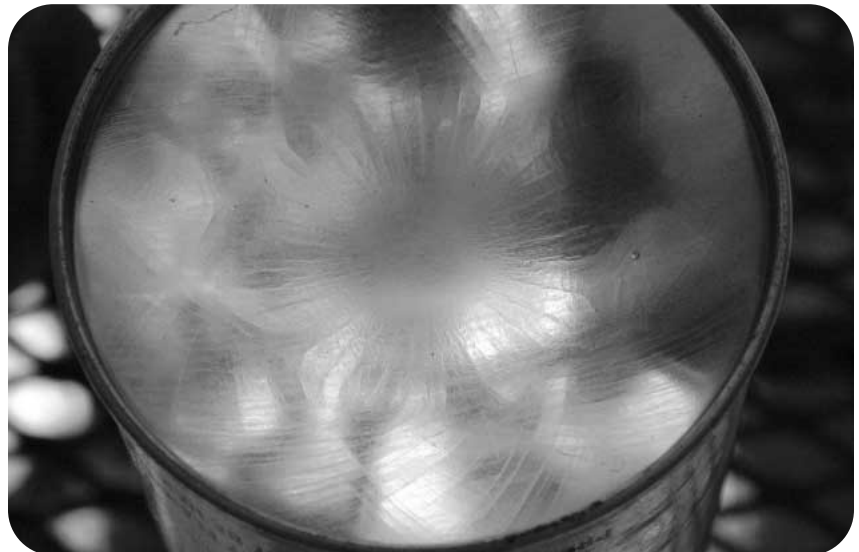
Example: Bottom of Aerosol Paint Can

Yield point elongation (YPE) is considered undesirable for surface-critical applications where the steel is formed, since “strain lines” or Luders bands are created during forming. Thus, steel manufacturers usually aim for zero YPE in these applications, tailoring their alloy and process design strategies and operating practices accordingly. In practice, a small amount of YPE (e.g. a few tenths of 1%) is usually considered acceptable, although there are no clear or uniform acceptance criteria, and decisions are usually made on a local basis by manufacturers, substantially influenced by commercial issues, and without clear technical guidance.
